**SITE SPECIFIC PROJECT PLAN FOR:**  
**BANK STABILIZATION IMPLEMENTATION AND ASSESSMENT OF THE**  
**CONNECTICUT RIVER NEAR COLEBROOK AND GROVETON, NEW**  
**HAMPSHIRE**

Fourth Draft  
October 21, 2005

*Prepared by:*  
John Field  
Field Geology Services  
P.O. Box 985  
Farmington, ME 04938

**Fluvial Geomorphology Assessment of the  
Northern Connecticut River, Vermont  
and New Hampshire**

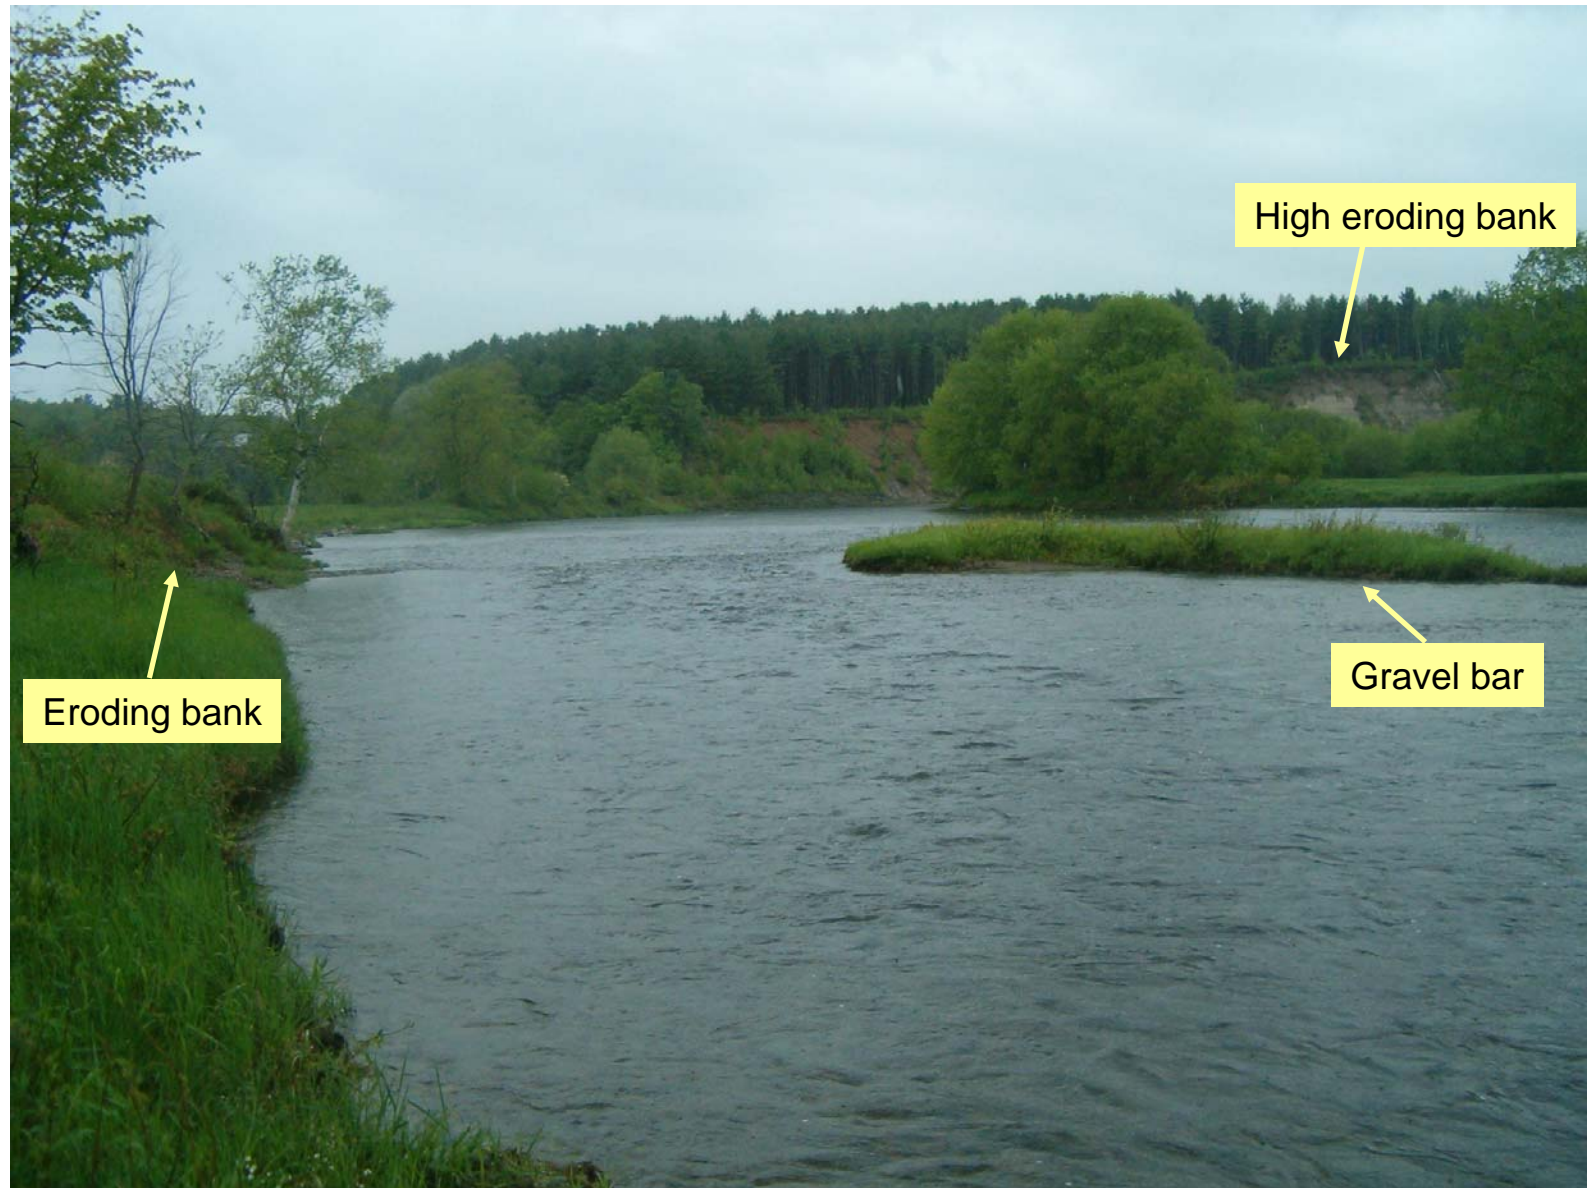
## Bar Formation Downstream of High Eroding Bank in Reach 8

Note: Erosion in foreground caused by flow deflection around gravel bar supplied by erosion of high bank in background

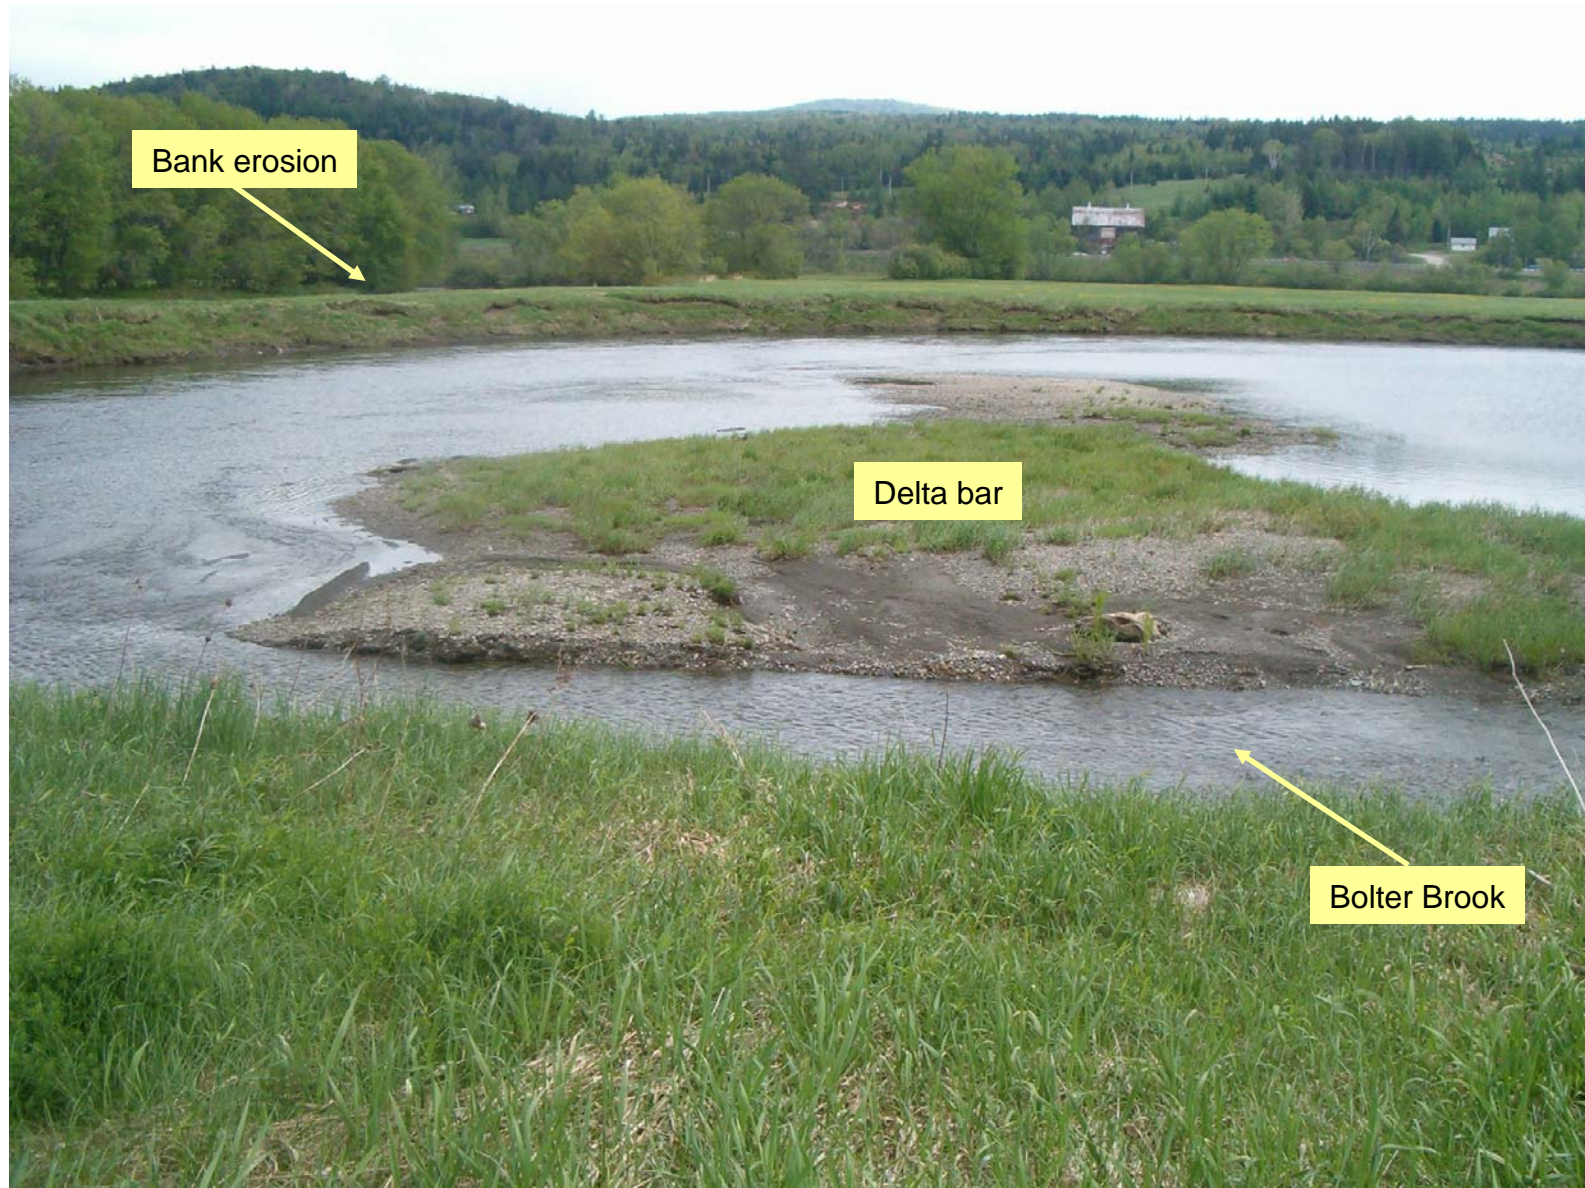
## Growing Delta Bar on Bolter Brook Causing Erosion of Opposite Bank

Bank erosion along the bank directly opposite tributary confluences was observed at several locations. Delta bars formed by sediment entering the mainstem at the mouths of these tributaries reroute the river towards the opposite bank, leading to erosion (Figure 8). The watersheds of those tributaries creating the delta bars have a high percentage of land clearance within them while adjacent tributaries with little land clearance have no significant delta bars or erosion on the opposite bank (Figure 21). If the entry point of the tributary into the mainstem shifts position so does the location of the erosion. In Reach 7 across from Bog Brook just below the Maidstone Bridge, riprap placed on the bank across from the previous location of the confluence is holding up well because the mouth of the brook has shifted upstream slightly causing erosion in a new location and relieving pressure on the area where the riprap was placed.

Note: In Reach 14

The formation of delta bars at tributary mouths leads to erosion along the opposite bank of the northern Connecticut River. Decreasing the rate of deposition on the delta bar would in turn relieve the erosive forces on the opposite bank. Consequently, addressing the cause of erosion requires decreasing the amount of sediment emanating from the tributary. This could be achieved by either decreasing sediment production in the tributary watershed or by increasing sediment storage along the tributary channel. The best approach to take in any given tributary would require further assessment of that tributary. Recognizing that extensive land clearance in small watersheds is responsible for delta bar growth on some tributaries, efforts to revegetate these watersheds could prove effective in reducing erosion on the mainstem (Figure 21). Assuming landowner willingness exists, the revegetation of a small watershed would be feasible. Efforts to increase sediment storage along the tributary channel would probably prove a more effective technique of limiting delta bar growth in larger watersheds where extensive revegetation efforts would prove more difficult. As conflicts arise resulting from erosion on the mainstem caused by delta bar growth, conditions in the tributary should be analyzed to better understand the cause of erosion rather than simply trying to protect the eroding bank. Simply armoring the bank or implementing bioengineering techniques will only prove effective for a short time period if sediment delivery to the mouth of the tributary is not limited.

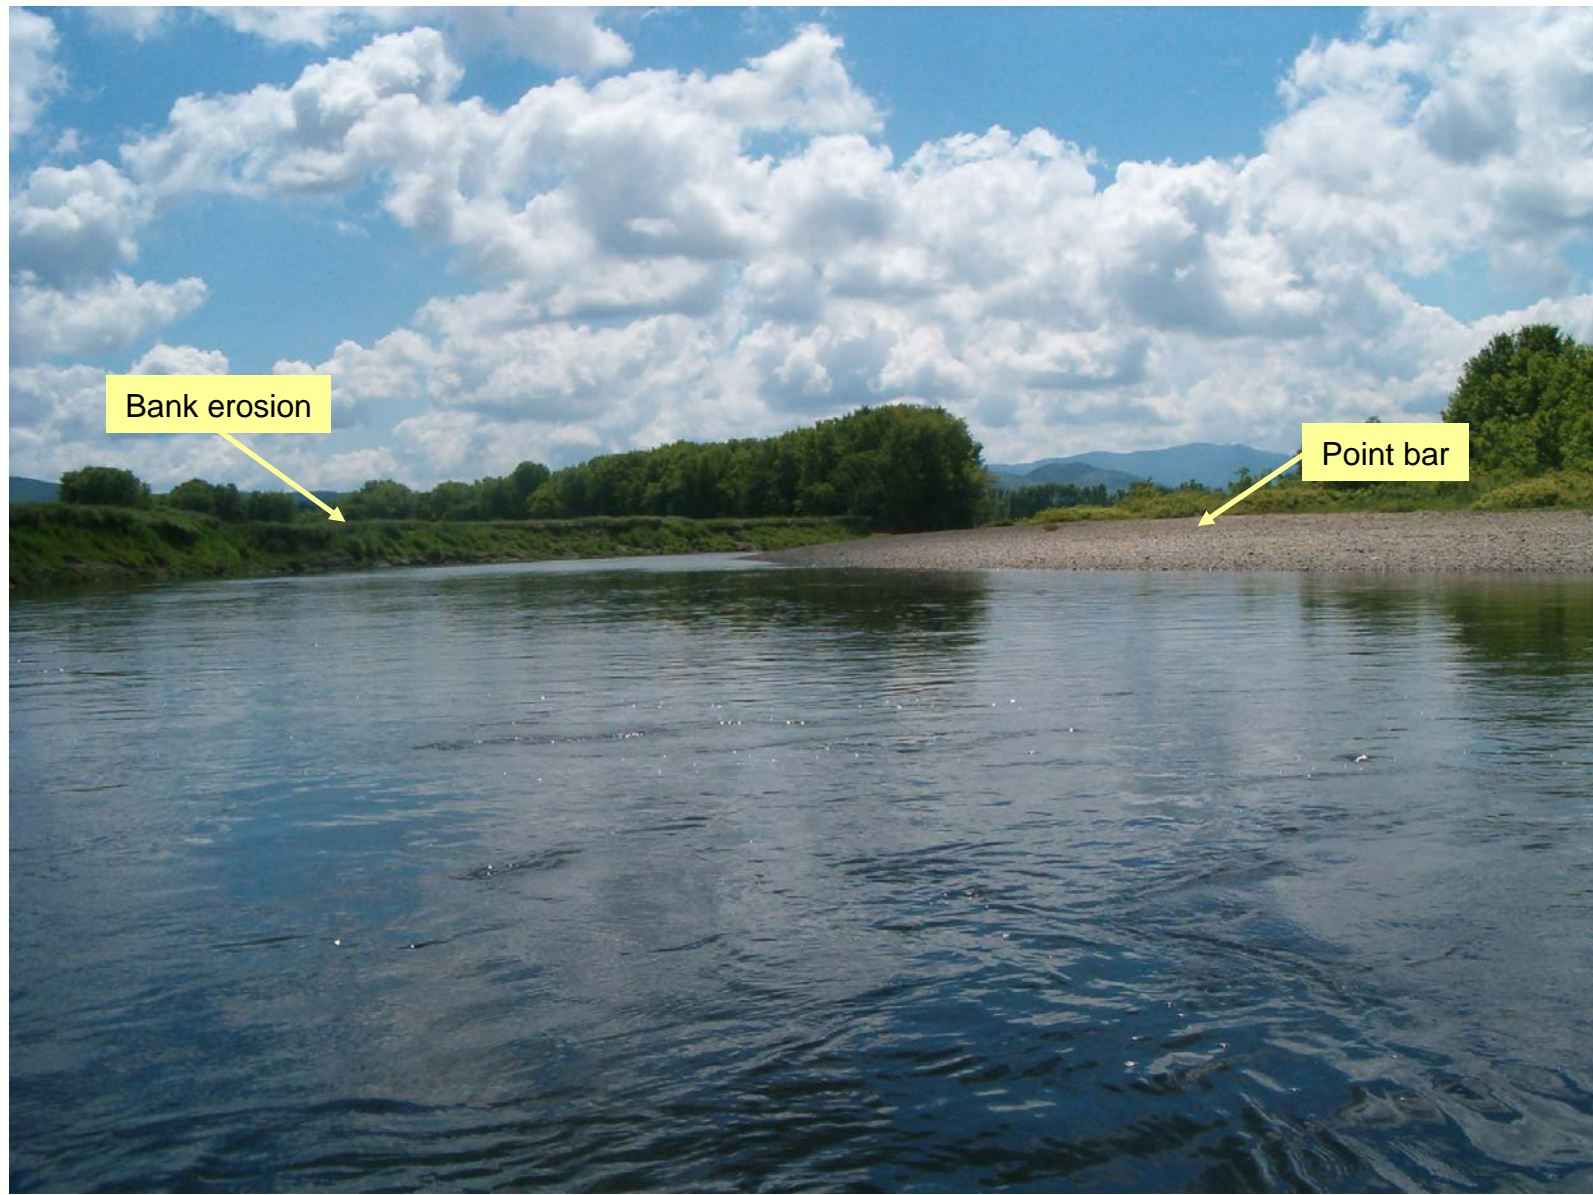
## Point Bar Formation Causing Erosion of Opposite Bank – Reach 7

Deposition of point bars on the inside of meander bends tends to force flow to the outside bend where erosion, consequently, occurs (Figure 9). This relationship between point bar deposition and erosion of the opposite bank is observed along almost every meander bend in Reaches 6 and 7. Reaches 6 and 7 have some of the highest rates of bank erosion of all 20 reaches on the northern Connecticut River (Table 3). Sediment delivery from the high banks of glacial outwash sediments in Reaches 8-10 is the likely source for the sediment deposited on the bars. The loss of stream power associated with the dramatic downstream decrease in channel gradient and loss of valley confinement between Reaches 6 and 10 results in the bar deposition and drives the bank erosion (Table 3).

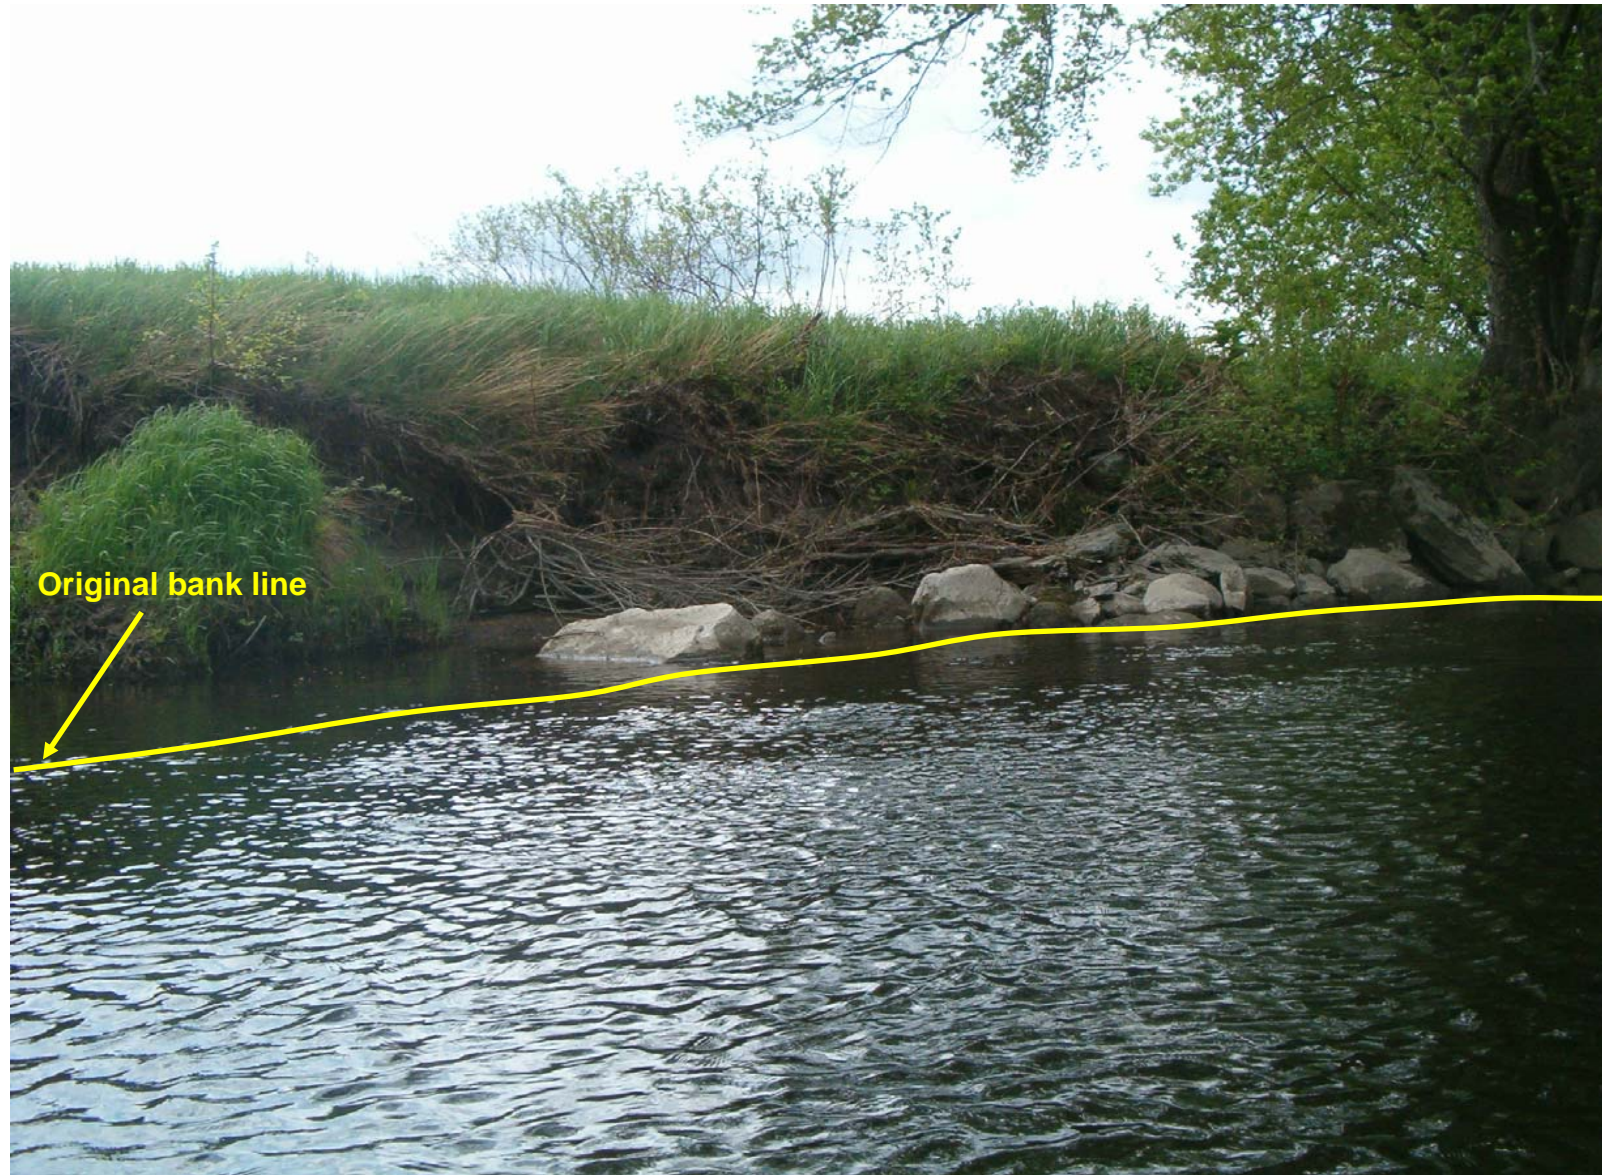
## Old Riprap Failing Along Straightened Channel

Erosion persists today on the northern Connecticut River as adjustments to channelization continue. Straightened channels, in most instances, are wider than adjacent meandering channels (Figure 3; Table 4; Appendix 4). The channels also tend to have greater bankfull depths, reflecting the bed erosion that is at least partially responsible for the channel incision observed along the river (Figure 6; Appendix 4 – Reach 3 Cross Section 2). These overwidened channels have relatively stable banks because the resulting increase in channel area has brought the channel back into equilibrium (Figure 17). After widening, a river channel will begin to backfill with sediment and establish a new floodplain as part of an evolutionary process that returns the river to its original pre-channelization condition (see Appendix 1 for a discussion of channel evolution models). Such backfilling appears to have occurred in Reach 6 where human additions of hay bales and mud have accelerated the process, led to the creation of a lower floodplain, and created shallower bankfull depths (Table 4; Appendix 4). Other straightened segments on the northern Connecticut River appear to have progressed far enough through the widening phase that banks have become restabilized after an earlier period of erosion (Figure 17). Whether human activity could have led directly to the creation of overwidened channels without natural erosion is unknown. In some instances riprap was placed on the banks of the straightened channels to stop the erosion and bank widening. The older riprap in these areas shows signs of failing because the channel has not yet fully progressed through the widening phase (Figure 18). The constant pressure on the banks resulting from locking the channel into a nonequilibrium condition eventually leads to the undermining and erosion of the riprap.

Note: In Reach 14

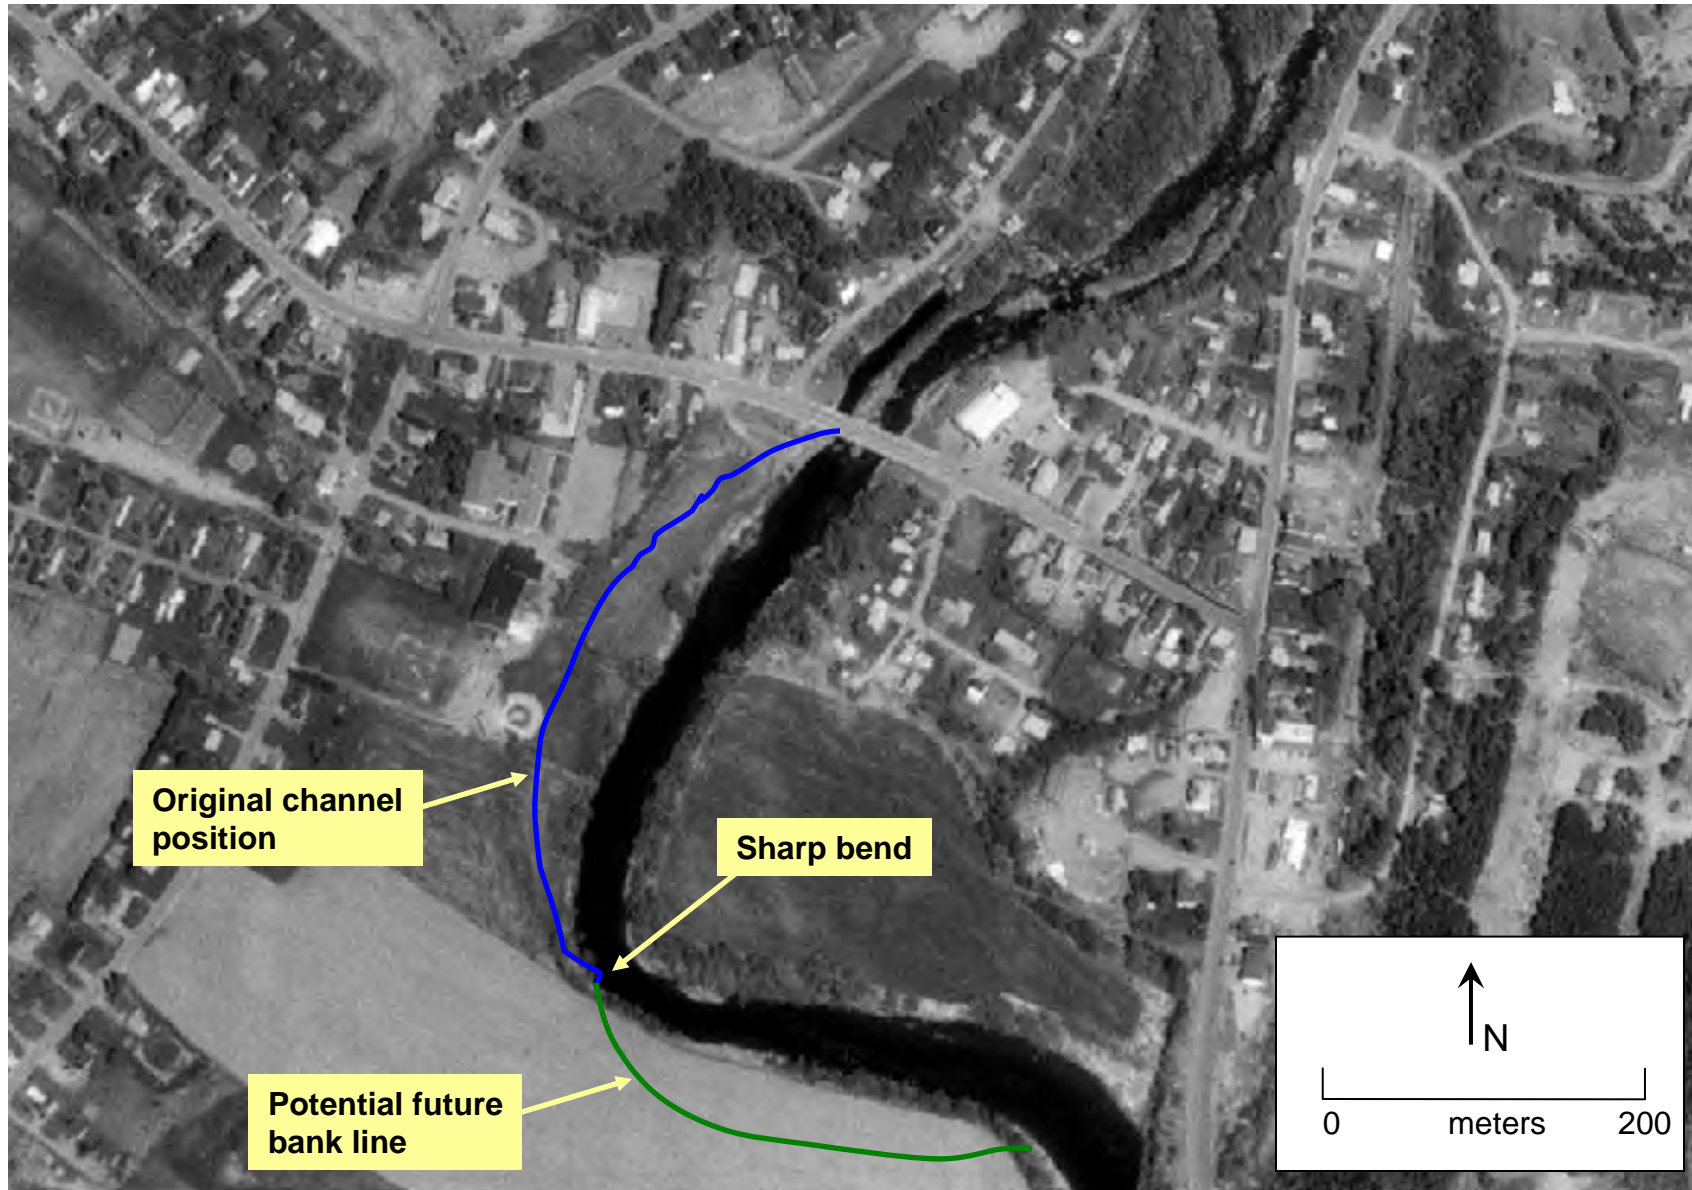
## Sharp Bend at End of Straightened Channel – Reach 15

straightened segments are repeatedly sharper than what were originally present (Figure 19a). Severe erosion is observed at many of these artificially “hard” bends as the river attempts to create a gentler meander so the turning, and energy expenditure along the channel, is spread out over a greater distance rather than focused at a single point (Figure 19). As a result, erosion extends downstream for some distance while banks immediately upstream of the sharp bend are generally stable. Riprap placed at these sharp bends to stop the erosion will fail over time because of the continuing pressure exerted on the banks at these bends (Figure 20).

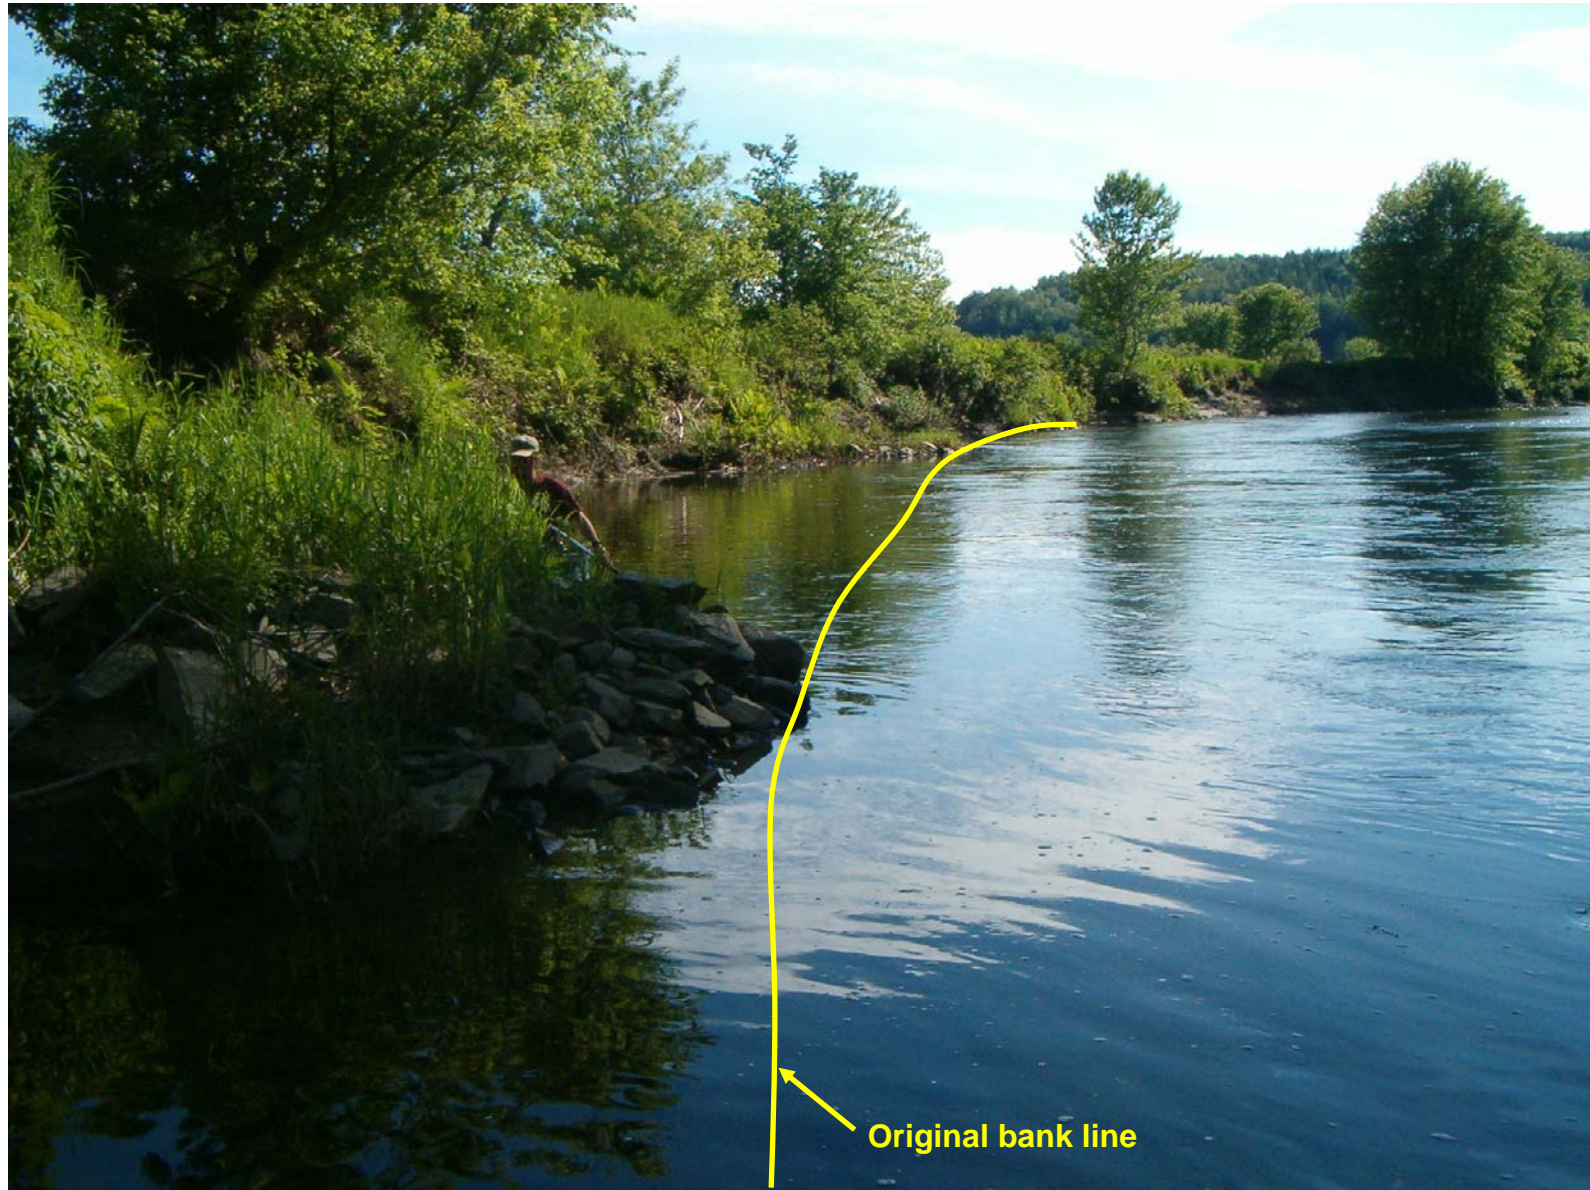
## Old Riprap Failing at Artificially Sharp Bend – Reach 14

Note: Bank has receded more than 6.0 m (20 feet) in places since construction of riprap

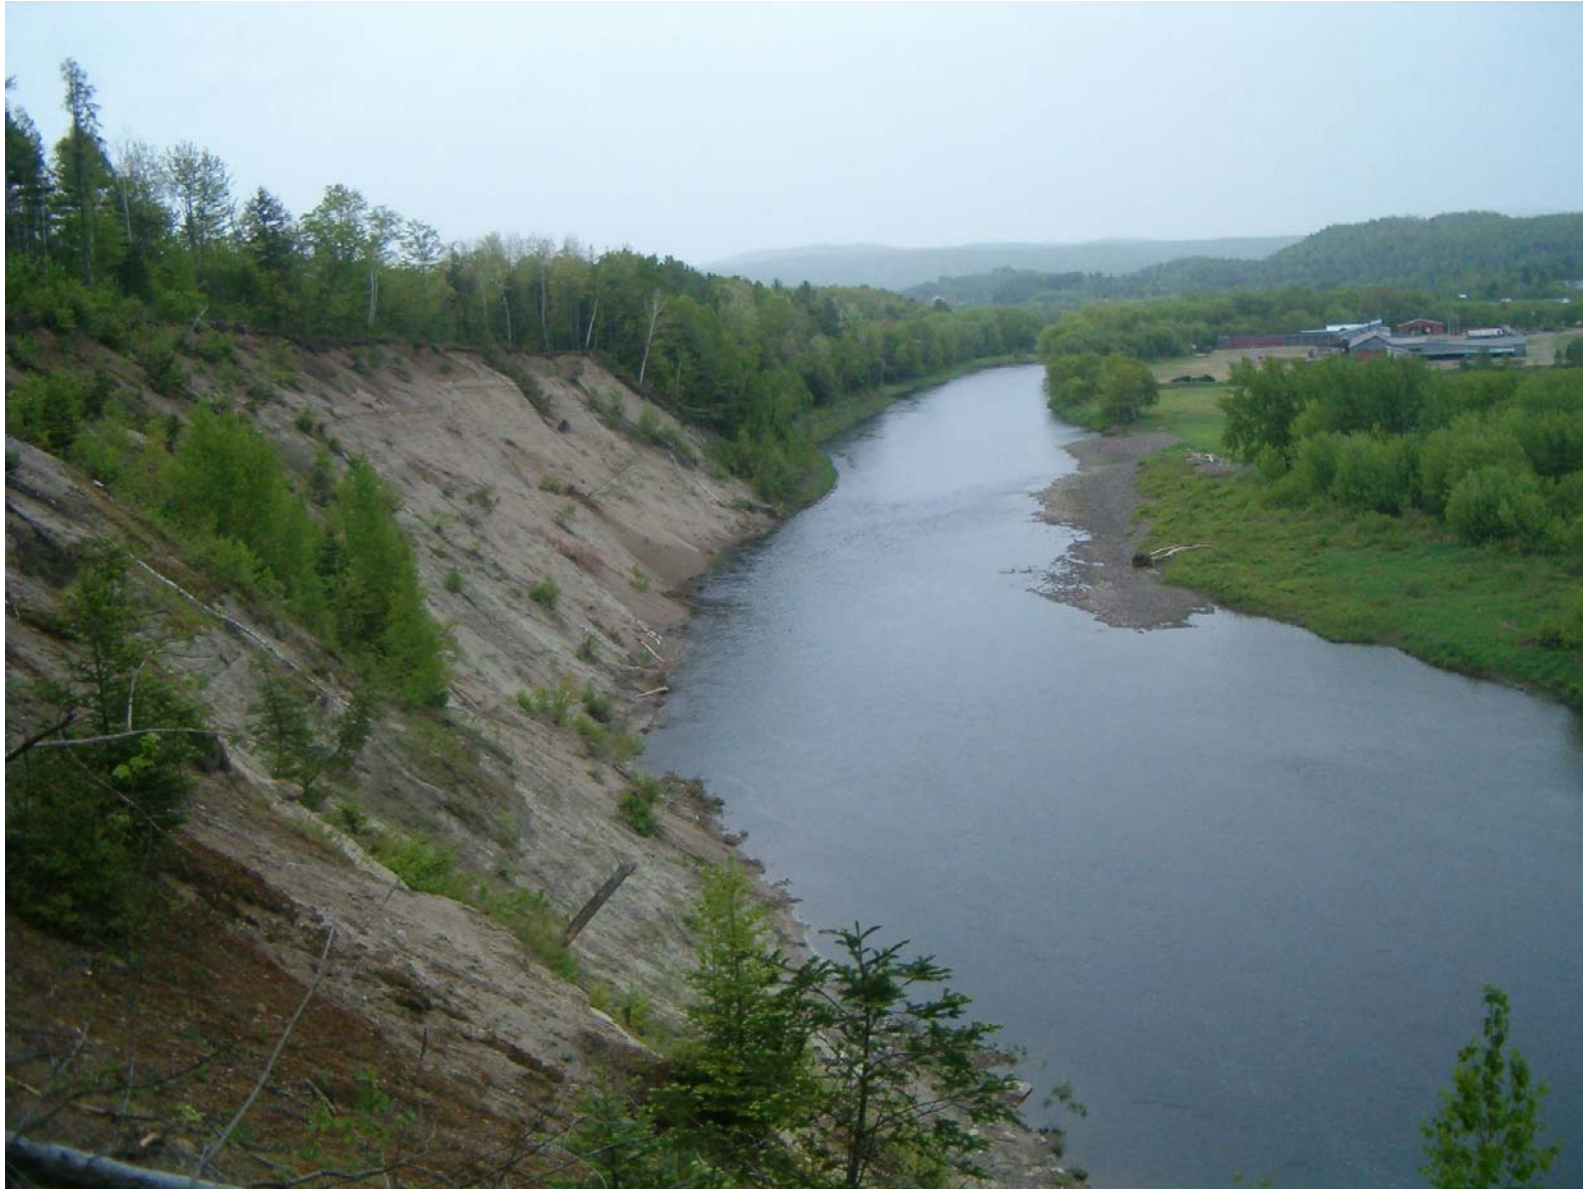
## High Eroding Bank of Glacial Outwash Deposits – Reach 8

Note: Near Brunswick Springs, VT

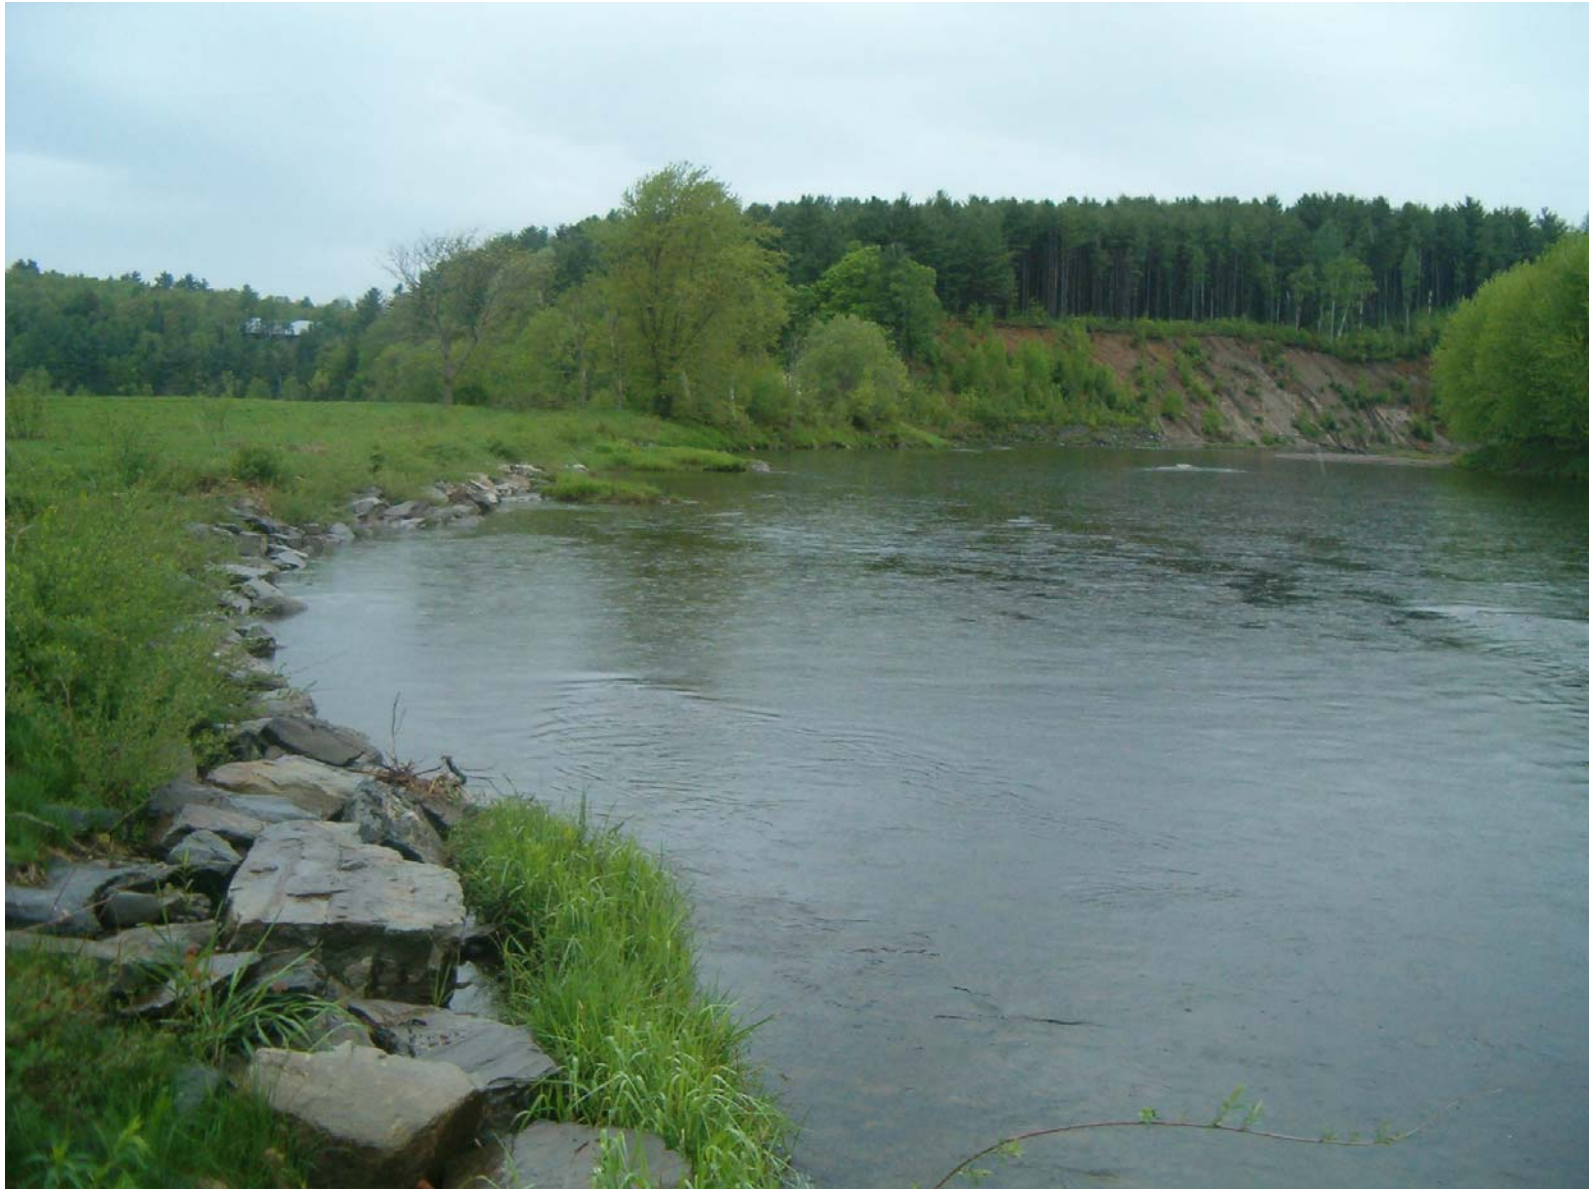
## Scalloped Bank Line Due to Erosion by Flow Diverted Around Mid - Channel Bar

Note: Mid - channel bar migrated downstream after riprap was placed on bank to stop erosion (Reach 8)

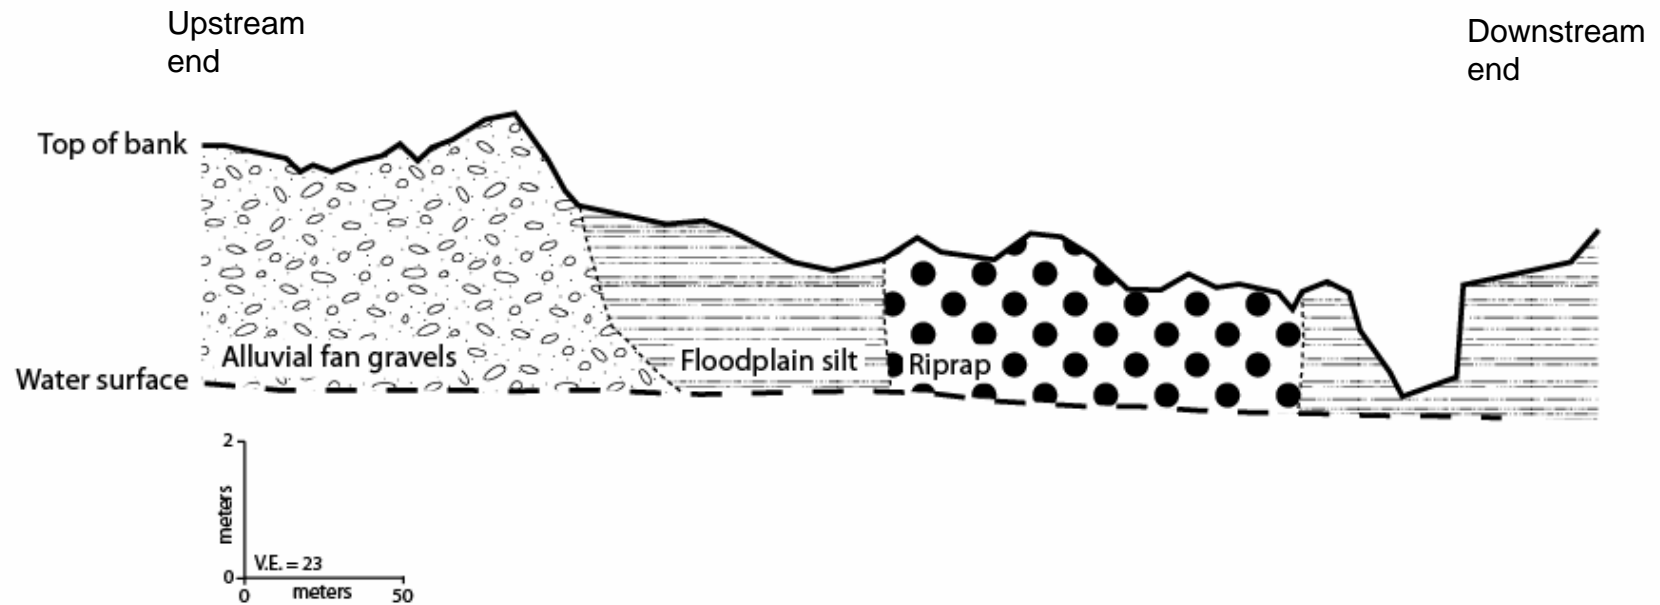
## Colebrook Industrial Park - Left Bank Profile

The upstream portion of the eroding bank at the Colebrook Industrial Park is a high bank composed of loose sand and gravel that is 2.0 m (6.6 feet) higher than the eroding floodplain silts downstream (Figure 30). Riprap is protecting a portion of the eroding floodplain deposits across from the mid-channel bar (Figures 28 and 30). The height and composition of the bank material is an important consideration in choosing the most effective management option for the site.
